MISCELLANEOUS PAPER SL-80-8

**CONCRETE AND ROCK TESTS
MAJOR REHABILITATION, DRESDEN ISLAND
LOCK AND DAM, ILLINOIS WATERWAY
CHICAGO DISTRICT, PHASE I REHABILITATION**

Structures Laboratory
U. S. Army Engineer Waterways Experiment Station
P. O. Box 631, Vicksburg, Miss. 39180

September 1980

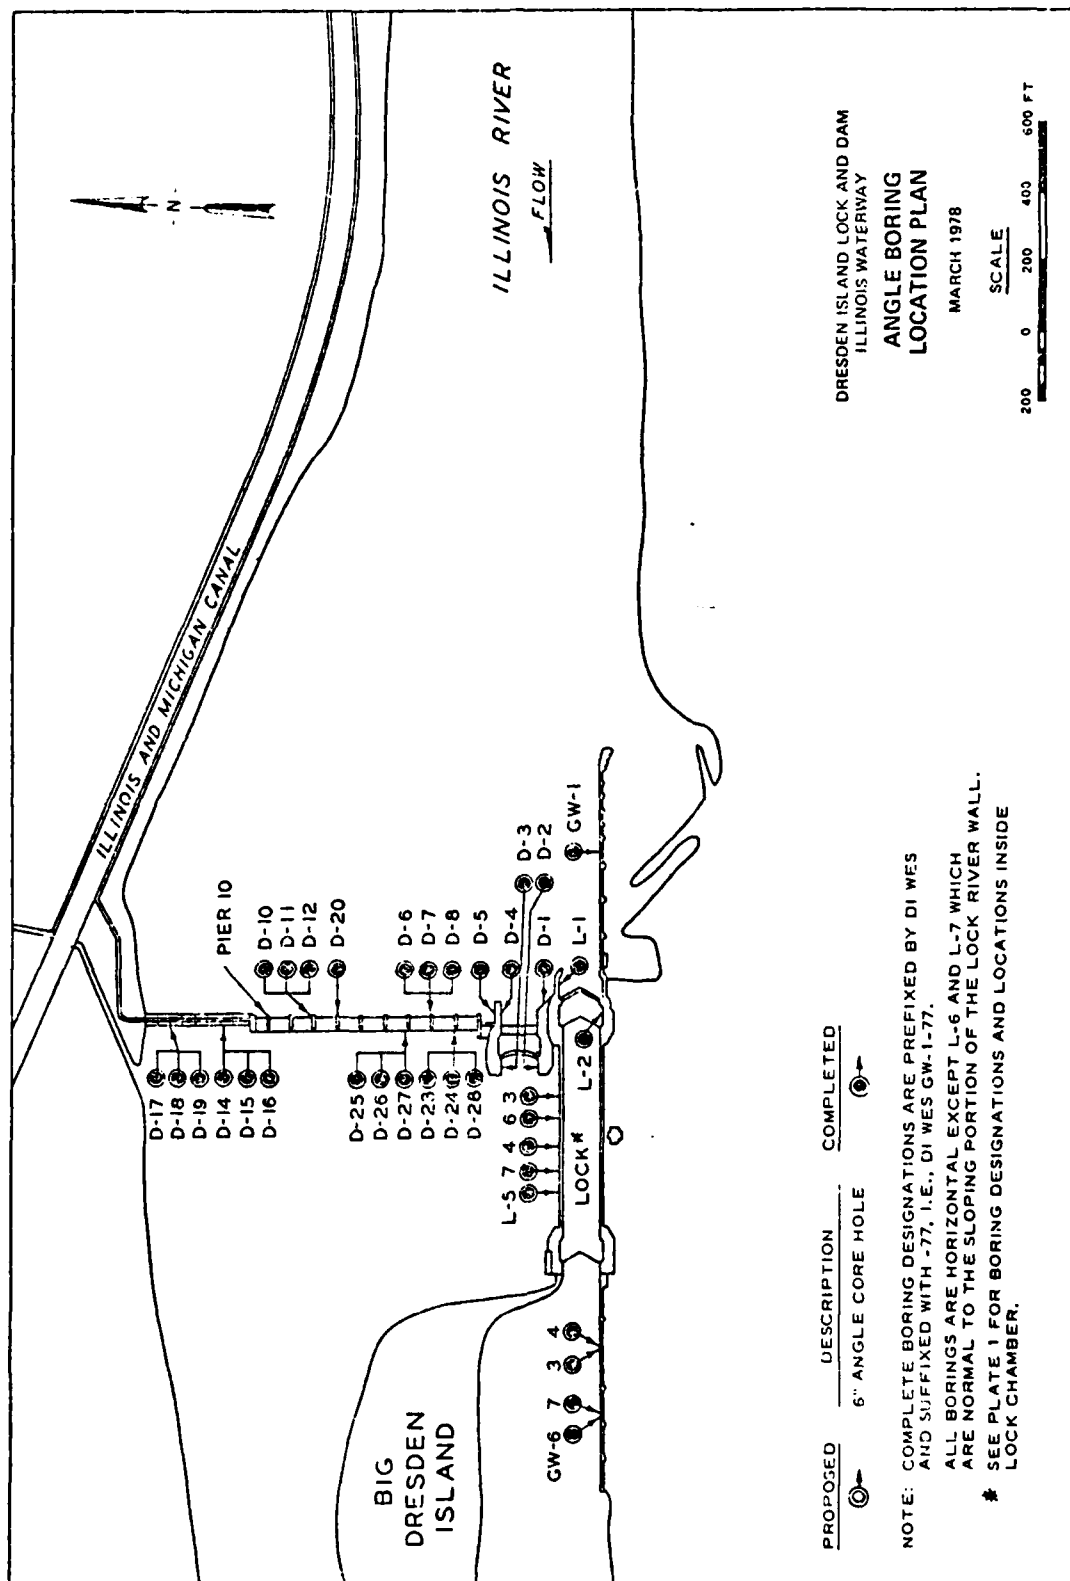
70. Depth of deterioration. The average depth of deterioration in the gate bays is 1.5 ft; the maximum depth is 1.6 ft in boring L-1 which was drilled into the riverward upper gate bay (see Figure 1b for location of borings). This extent of damaged concrete in a location subjected to high stress, such as a gate bay, is considered extremely dangerous.

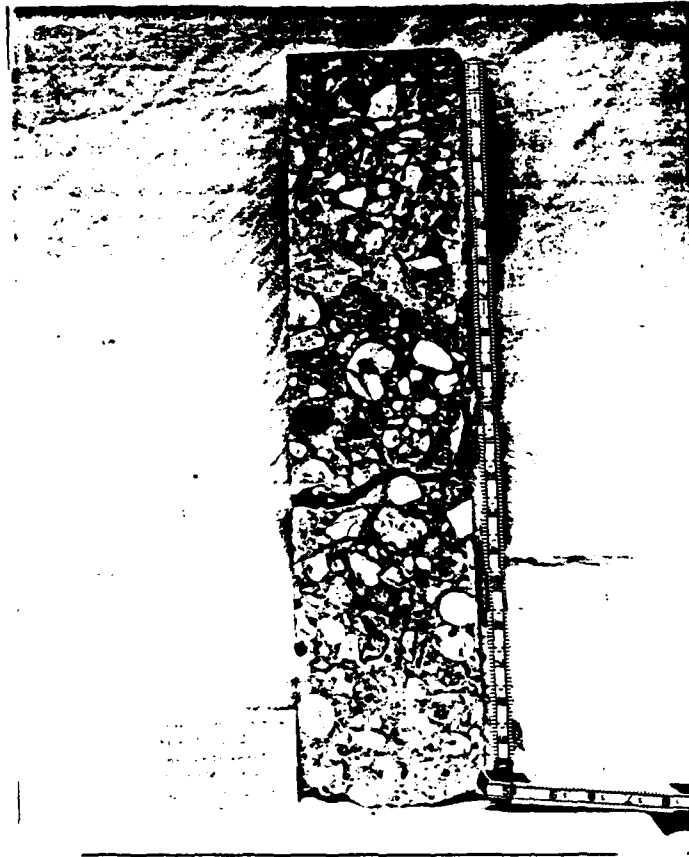
Figure 3. New and Old Concrete

60. The concrete varied in physical condition. The new concrete was intact and in good condition but as shown in Figure 3 the old concrete in boring D-1 is fractured to a depth of 1.5 ft. This depth is about 0.7 ft below the contact of the new and old concrete. In boring D-6, as illustrated in Figure 4, and in boring GW-5 a crack exists about 0.1 ft deeper than the contact of the old and new concrete. In boring GW-2 an old crack exists at the contact of the old and new concrete. Borings GW-1 and GW-8 were the only other borings with new concrete overlying the old concrete. The concrete was intact and in good condition throughout the entire length of core.

New concrete ends at about 0.8 foot depth and old concrete is below it. Parallel to subparallel fractures are to a depth of about 1.5 feet.

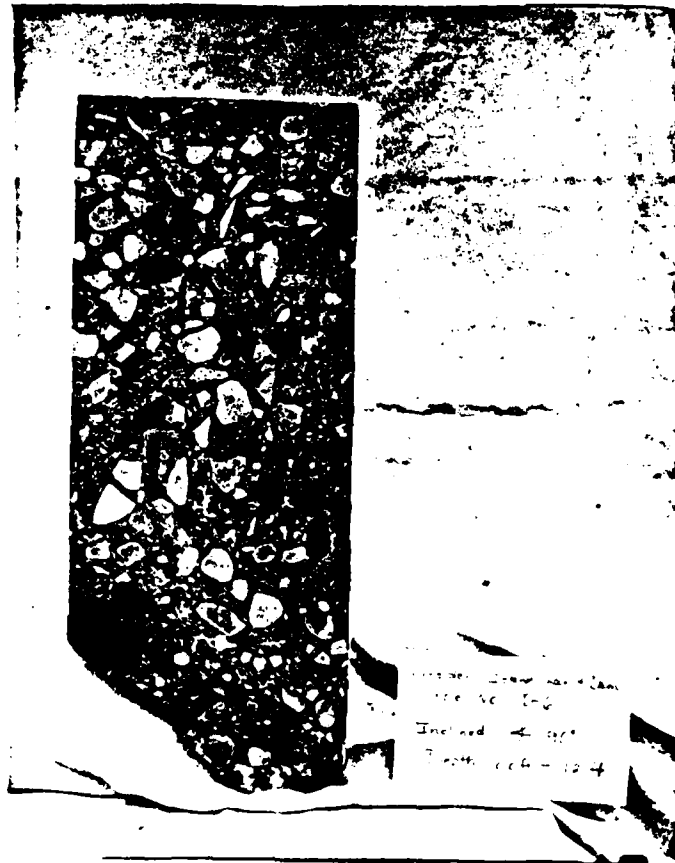
Figure 4.

New concrete is to a depth about 1 foot. The break parallel to the contact of the old and new concrete was considered to be old.

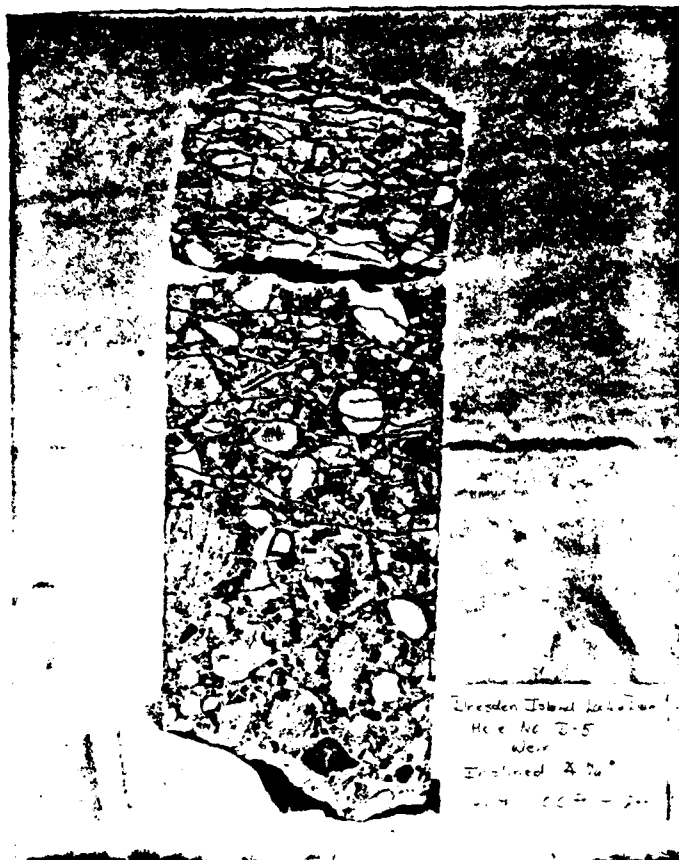
Figure 5. Effects of frost action

61. The near surface old concrete in some areas was intact and did not show any signs of deterioration. Other areas were highly fractured but remained relatively intact as illustrated in Figures 5 and 6. In other areas the surface had scaled off and the concrete near the surface was not intact as shown in Figure 7.

62. The depths of deterioration shown in Plates 10-15 are caused by frost action. This deterioration of the concrete was characterized by cracking parallel and subparallel to the surface of the concrete. The cracks propagate through aggregate as well as the paste. The depth of frost damage of the concrete was indicated at the deepest point when cracking was through the aggregate and paste.

The parallel and subparallel fractures decrease in frequency as the depth increases. The near surface fractures have been wedged apart by frost action and is easily removed.

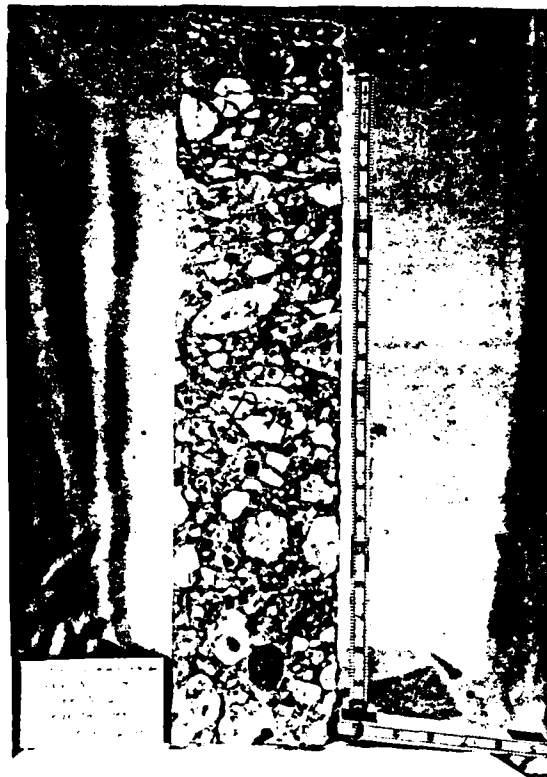
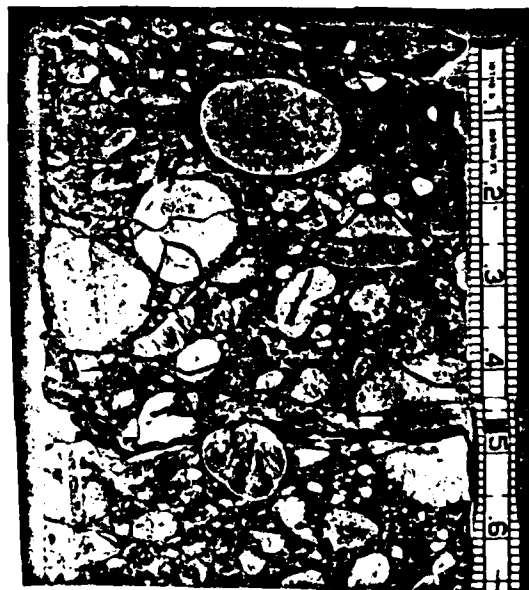
Figure 6. Effects of frost action.

Not all of the fractures were caused by frost action. Some of the fractures were caused by poor consolidation as shown by vertical crack near the bottom of this piece of core.

A close up of D-14 shows fractures going through paste and extending into aggregates. The near surface pieces were easily removed.

The lower velocity of the near surface concrete reflects the subparallel cracking in the concrete (see Figure 6 for example). However, the strength of the same core does not indicate the damaged concrete. The reason is that often times cracks in cores that are perpendicular to the axis of applied load have little effect on compressive strength.

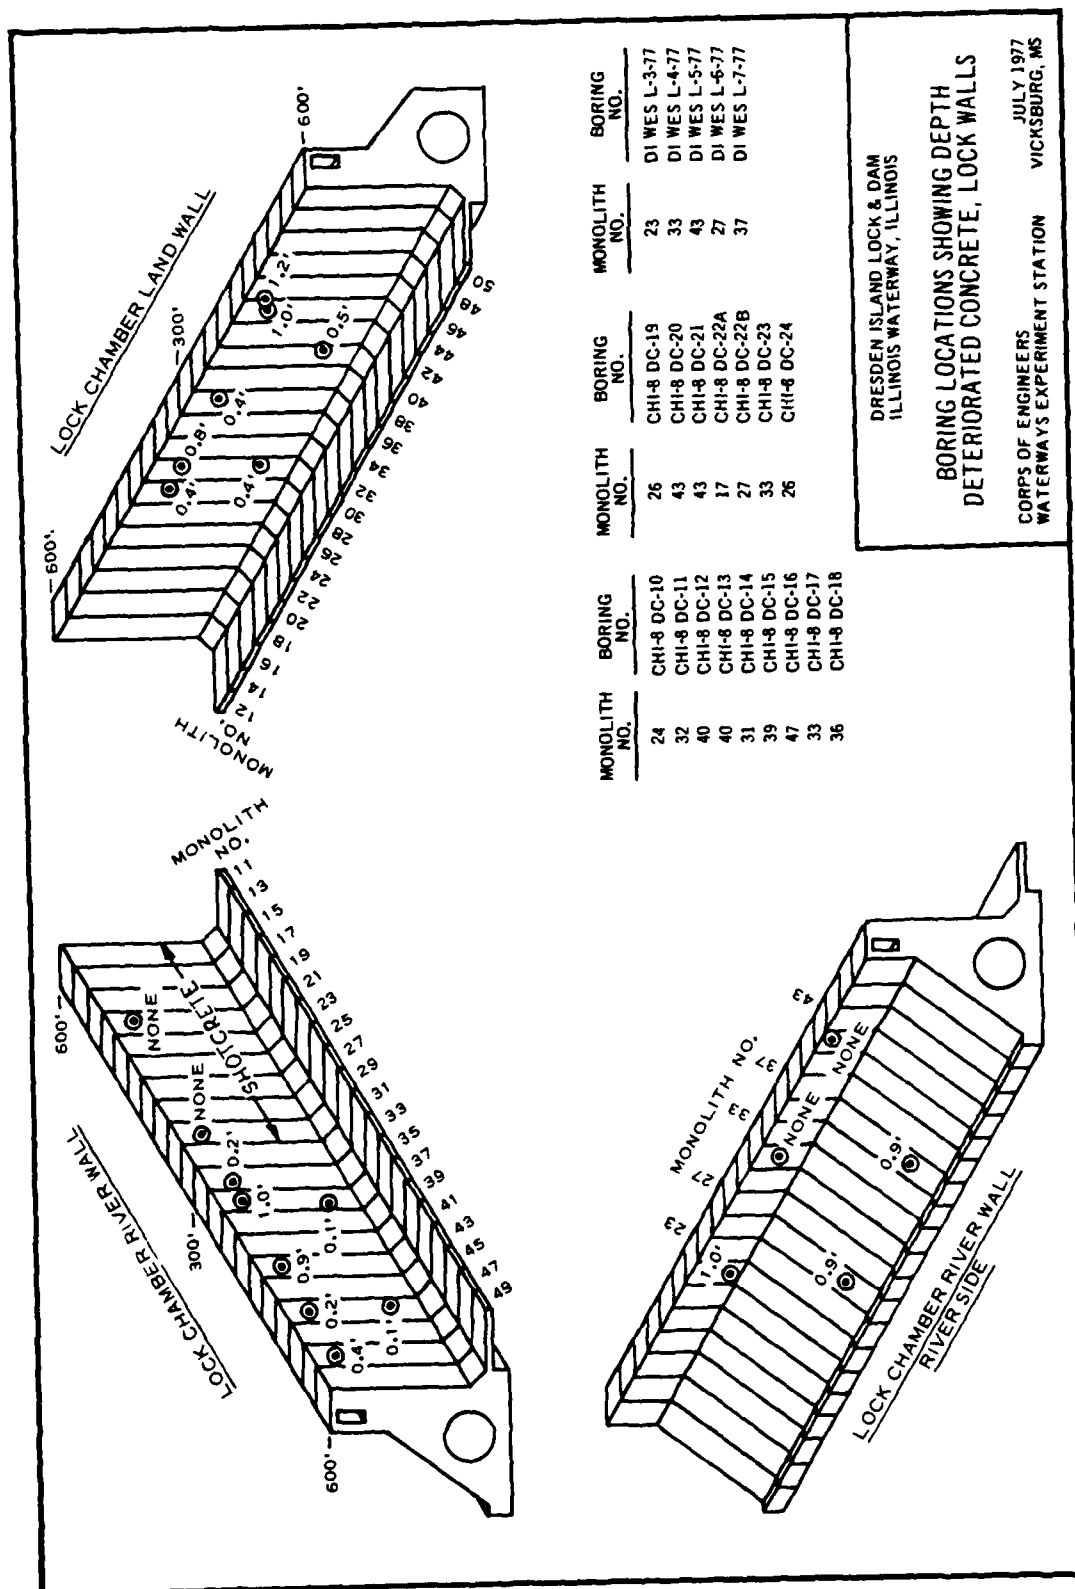
BORING LOCATIONS SHOWING DEPTH
DETERIORATED CONCRETE, LOCK WALLS

64. Depth of deterioration. The average depth of concrete deterioration through the eroded portion of the wall is 0.7 ft; the maximum depth is 1.2 ft (see Figure 8 for depth of deteriorated concrete for each hole). Figure 8 is a duplicate of Plate 1 which shows both boring locations and depth of deterioration; it is presented here for continuity. The total depth of deterioration as measured from the original face of the lock wall is the sum of the eroded depth and of the present frost damaged concrete. The deepest damaged concrete is near the top of the wall.

66. Depth of deterioration. The average depth of deteriorated concrete throughout this side of the wall is 0.7 ft; the maximum depth is 1.0 ft (see Figure 8 for depth of deteriorated concrete for each hole). The deepest frost damaged concrete is near the top of the wall. All of the cores exhibit frost damage near the vertical lock wall surface.

68. Depth of deterioration. The average depth of concrete deterioration in borings L-3, L-6, and L-7 is 0.9 ft; the maximum depth is 1.0 ft. Frost damage was not evident in borings L-4 and L-5 (see Figure 8 for location). It is possible that the areas where no frost damage showed up in the cores, the concrete was well consolidated and the surface not cracked so that water could penetrate the concrete. Severe erosion and scabbing of the concrete is occurring in many locations along the wall.

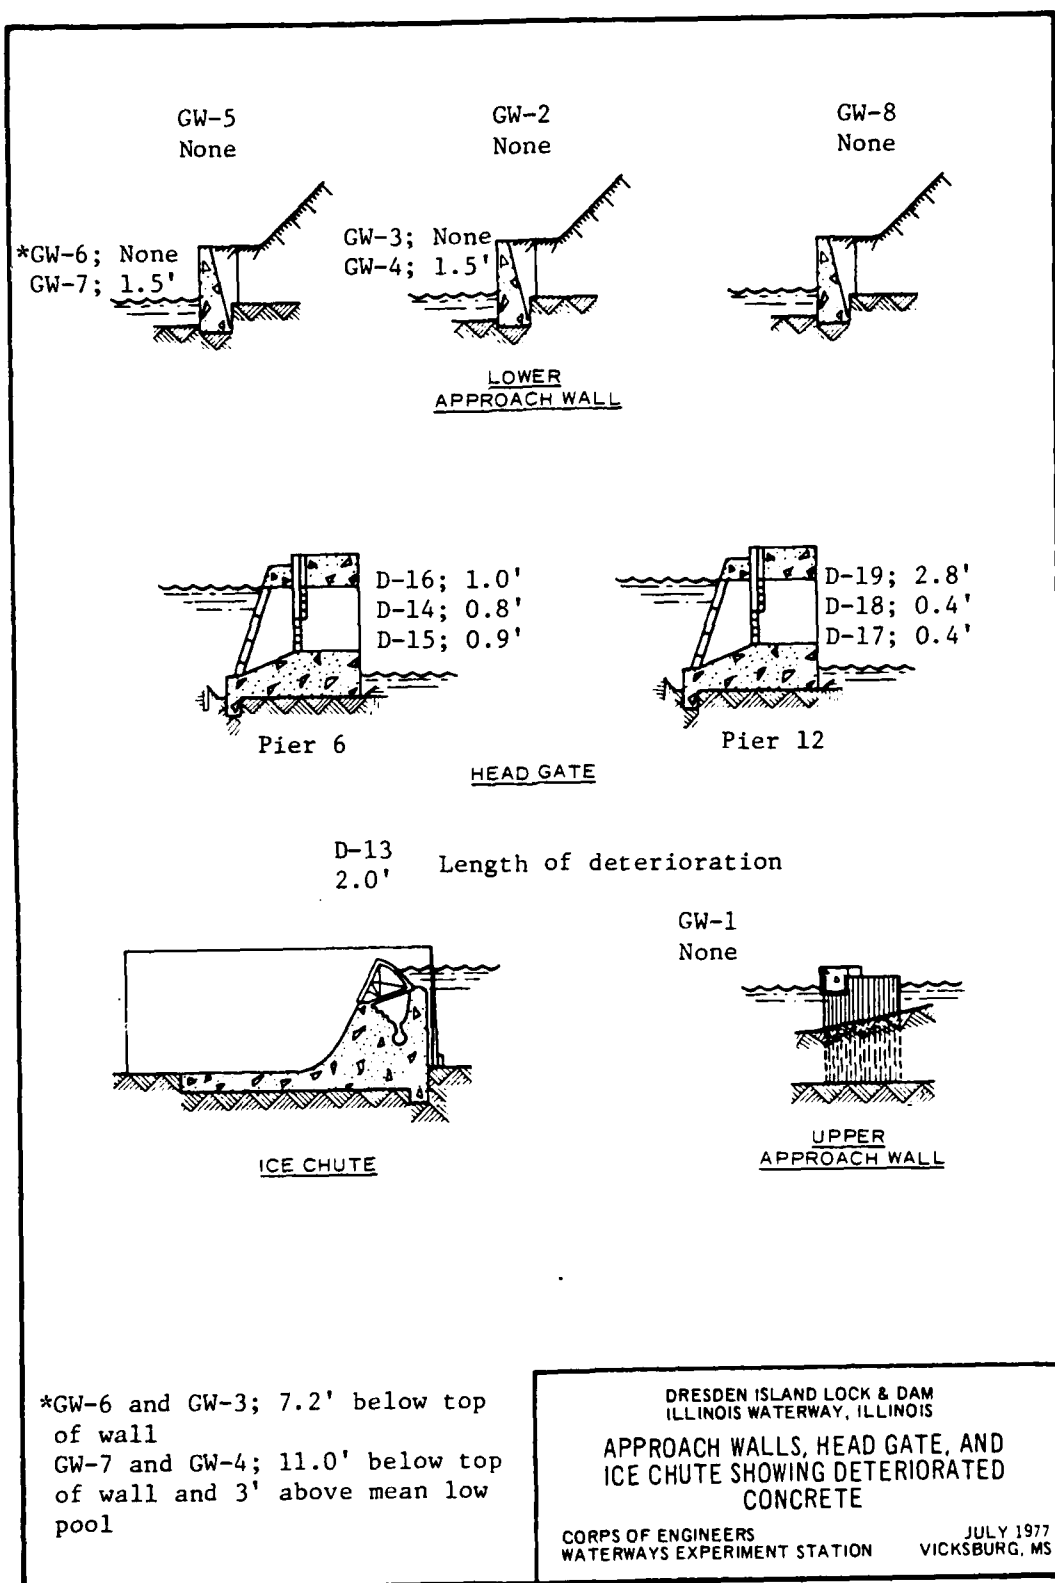
76. The average depth of damaged concrete in the lowest horizontally drilled holes (11 ft below top of wall) is 1.5 ft; this corresponds to the maximum depth of bad concrete. Figure 9 presents details of the damaged concrete in the lower approach wall. The vertical borings were 3.0 ft back from the face of the wall and did not encounter the damaged concrete observed in the core from the lowest borings. It is assumed that the damaged concrete is present in a zone from 7.2 ft below top of wall to a foot or so below mean lower pool and 1.5 ft into the wall. Severe erosion was noted at the monolith joints and at the water line.

86. Depth of deterioration. The average depth of deteriorated concrete in the head gate piers and sills is 1.0 ft; the maximum depth is 2.8 ft. See Figure 9 for damaged concrete at each of the boring locations. The greatest frost action has occurred on the downstream face of the piers just under the overhead slab.

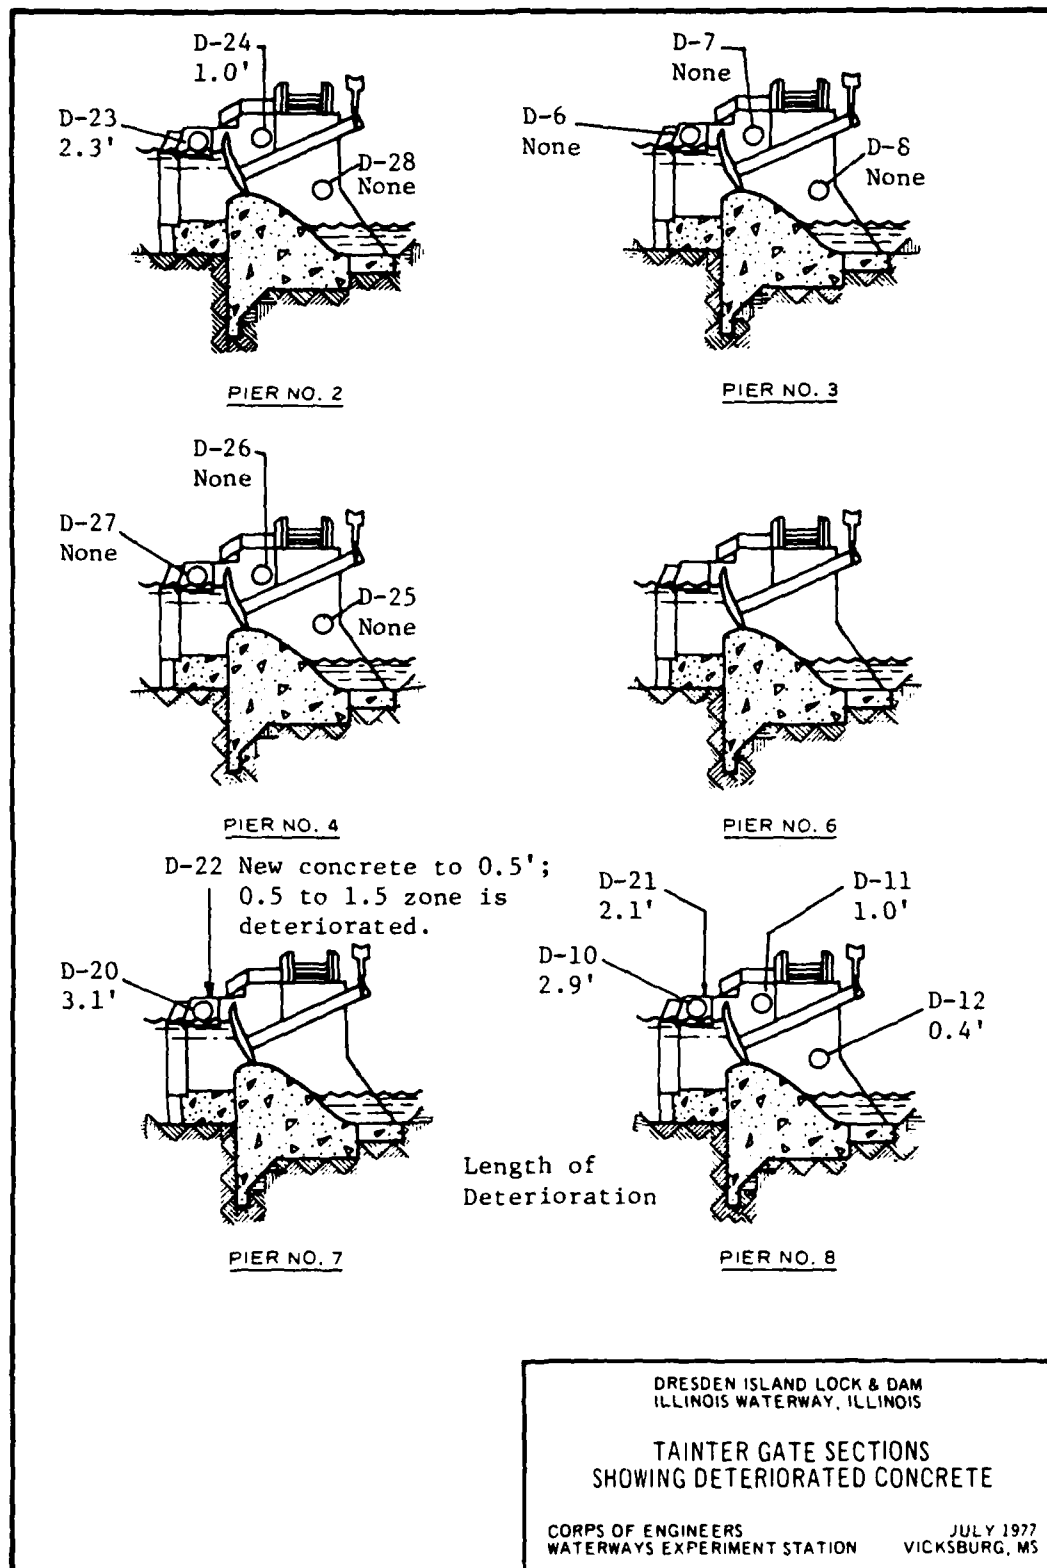
Figure 10

81. Depth of deterioration. No damaged concrete caused by frost action was detected in the three borings drilled into pier No. 3; see Figure 10. However, there were signs of erosion on the sides of the pier

82. The average depth of deterioration in the upstream one-half portion of pier 2 is 1.7 ft; the maximum depth is 2.3 ft. The average depth of deterioration in that portion of piers 7 and 8 from about 10 ft in front of the tainter gate and upstream to the nose of the pier is 2.3 ft; the maximum depth is 3.1 ft in pier No. 7, boring D-20. It appears that the greatest amount of frost damaged concrete in the tainter gate piers occurs in the upstream one-half portion and above mean upper pool elevation. Severe erosion has occurred at the upstream water line around the nose of the piers. Up to 0.4 ft of damaged concrete was found in boring D-12 located near the downstream edge of pier No. 8 (see Figure 10); no damaged concrete was detected near the downstream edge of piers 2 and 4.

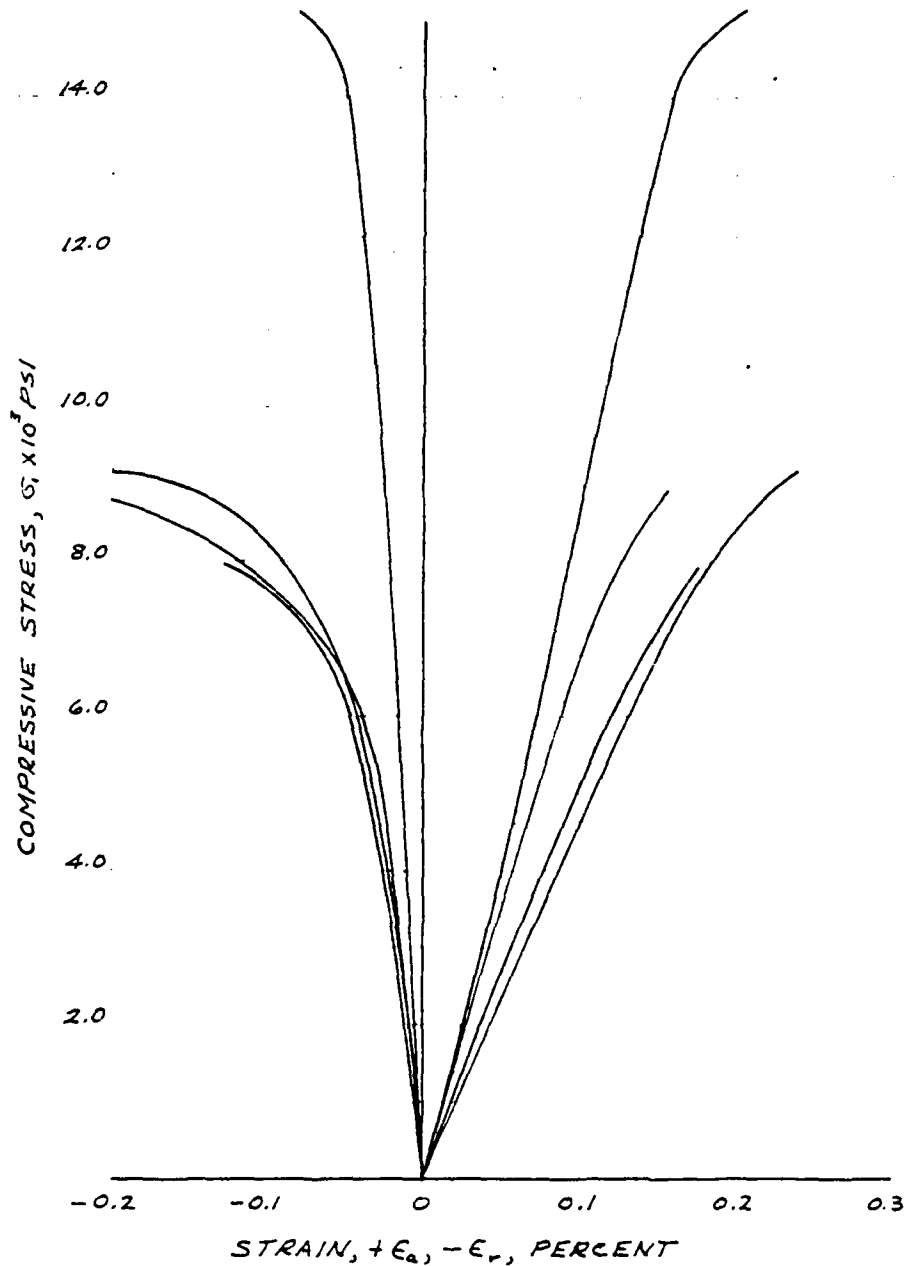
STRESS-STRAIN RELATION FOR LIMESTONE, DI LOCK DAM

Hole No.	Elev. Ft.	σ_1 PSI	Modulus $E \times 10^6$ PSI	Poisson's Ratio	Water Content Percent
GW-2	471.1	15,170	6.82	0.21	1.0
GW-8	472.4	7990	5.17	0.34	0.6
GW-8	471.3	9200	4.29	0.20	0.8
GW-8	469.4	8980	5.77	0.28	1.1

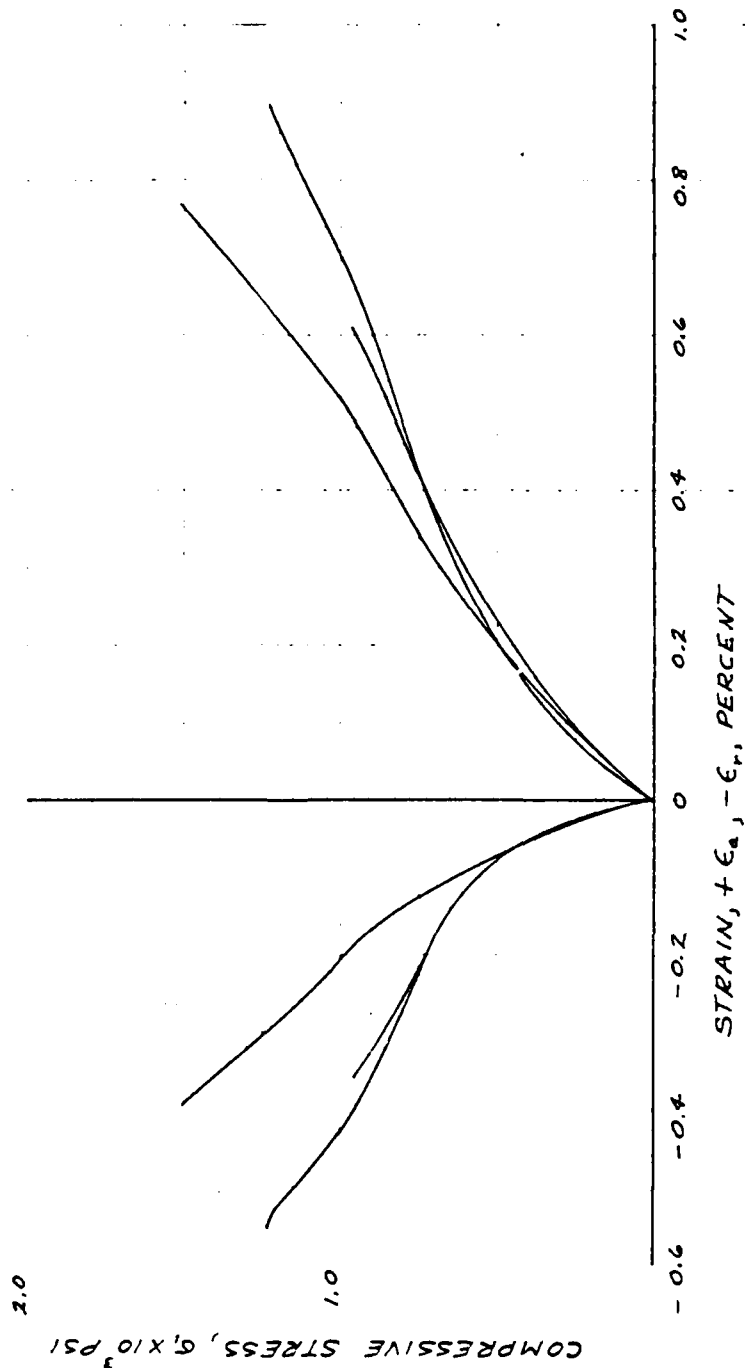
STRESS-STRAIN RELATION FOR SHALE, DI LOCK DAM

Hole No.	Elev Ft.	σ_1 PSI	Modulus $E \times 10^6$ PSI	Poisson's Ratio	Water Content Percent
GW-2	462.5	1230	0.25	0.37	6.4
GW-2	460.4	950	0.24	0.40	8.5
GW-2	457.7	1520	0.25	0.30	7.2
